SAFETY ALERT

Safety Alert No. 360
July 11, 2019

Collision Leads to Significant Near Miss

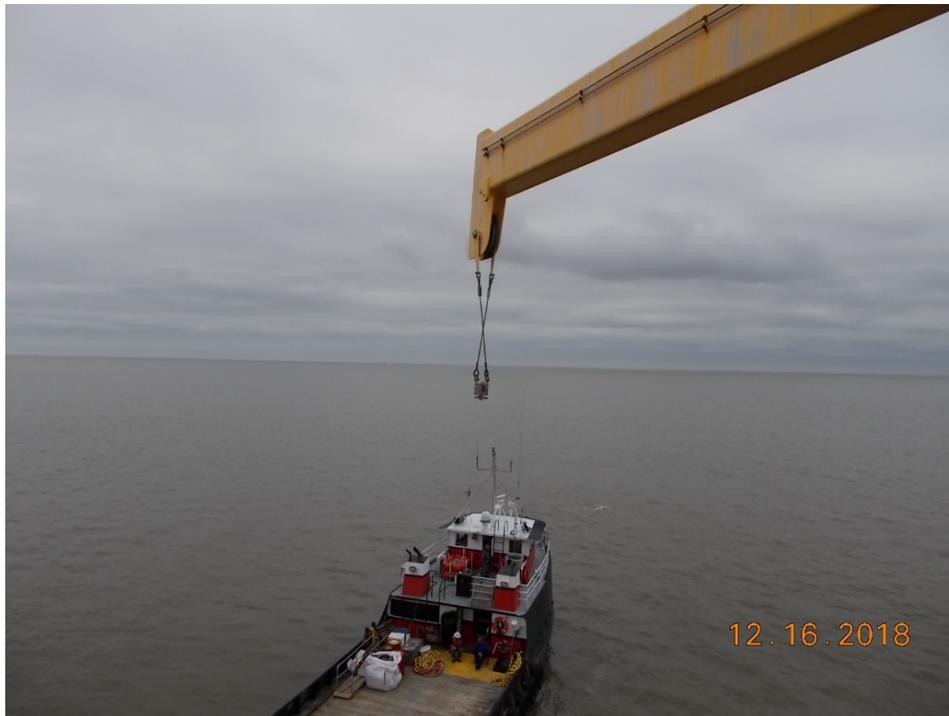
Out of service crane from which the load block fell in close proximity to a nearby vessel.

On Dec. 16, 2018, a motor vessel collided with a facility boat landing while preparing for a personnel swing rope transfer. The impact caused a load block on an out-of-service crane to fall into the water in close proximity to the vessel. Upon inspection, the operator found that the load line was broken just above the rope socket, causing the block to fall overboard. Severe corrosion was observed by the operator.

The crane was placed out of service in 2004, and no routine maintenance had been performed on the crane since then. Prior to the incident, the unsecured load block hung over the side of the facility.

- Perform at least a visual inspection of out-of-service cranes when conducting scheduled crane inspections;

- On all cranes that have been placed out of service, secure the load block and/or headache ball to the facility's deck in a manner that would prevent it from falling; *or*
- Remove the load block and/or headache ball from all cranes that have been permanently placed out of service; and
- Apply the proper lubricant to all wire rope on any crane that is to be out of service for long periods of time.
